SUBJ: SIGNIFICANT INCIDENT REPORT - INITIAL

SUBJ: COLLISION HMCS PRESERVER - INITIAL REPORT

HULL SURVEY SHEET FOR		DISTRIBUTION LIST	
HMCS Preserver		CDTL - original copy	
COMPONENT STRUCTURE		ENG/NAO/Hull Survey Office - file copy	
		LOCATION	FORE PEAK
		Fore Peak - FR10	01, 1
		FRAME	DECK
			STBD SIDE
JUSTIFICATION FOR SURVEY			
1. Survey and prepare repair instructions for damage to bow.			
REF: FMFCS Job No. 820161471		REF DWG NO.: 509-H26-21228, 509-H26-21234, 509-H26-21237	
DESCRIPTION OF WORK REQUIRED

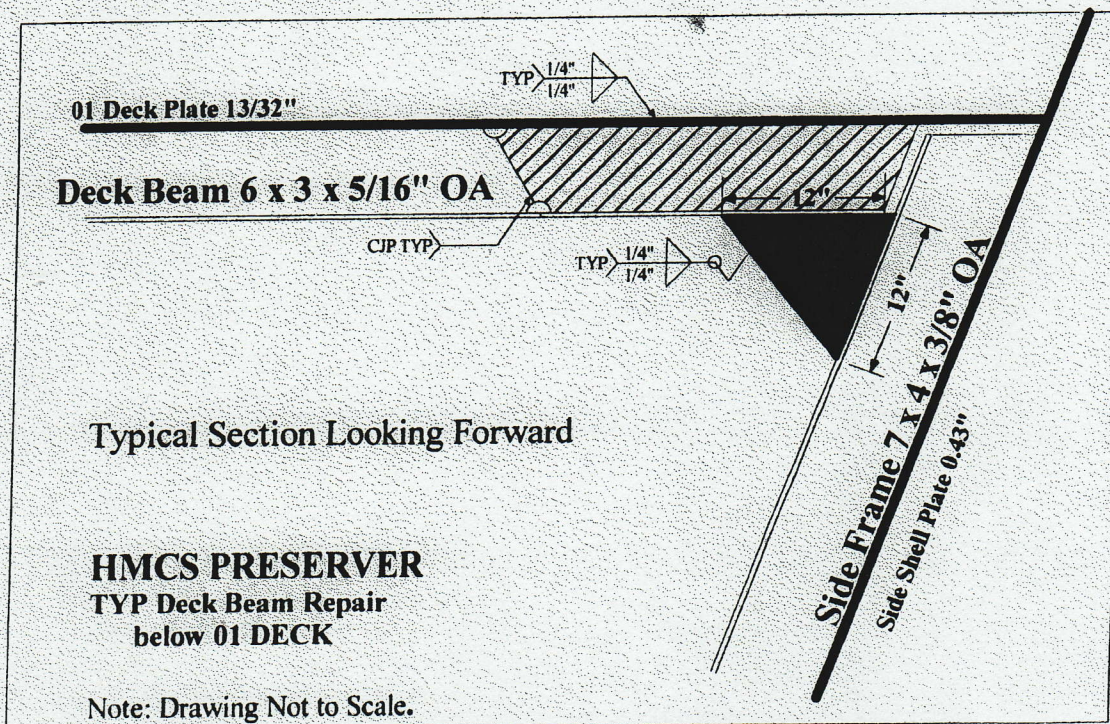
9. The deck beams and brackets connecting 01 DECK beams to STARBOARD side frames are "tripped" and distorted in the following locations:
- a. STBD - Frame 10
 - b. STBD - Frame 7
 - c. STBD - Frame 0
 - d. STBD - Frame E
 - e. STBD - Frame F
 - f. PORT - Frame F
 - g. STBD/PORT at Frame J - this deck beam tripped on both ends and in middle. Full replacement of deck beam required, complete with two (2) brackets. Deck beam may be installed in two pieces with one butt joint off centre at 30 degree angle.

- h. Repair tripped deck beams by cropping distorted sections and replace with new steel shape, and fabricate and install new brackets. See attached sketch.

Material required:

- 1 sheet 4' x 8' x 13/32" plate CSA G40.21-M 260WT Cat 5 (21J @ -40 deg. C)
2 pieces of 20' length 6 x 3 x 5/16" IA angle
